MiniBooNE Report

02 April 2007

Week Summary 26 Mar – 02 April Offline

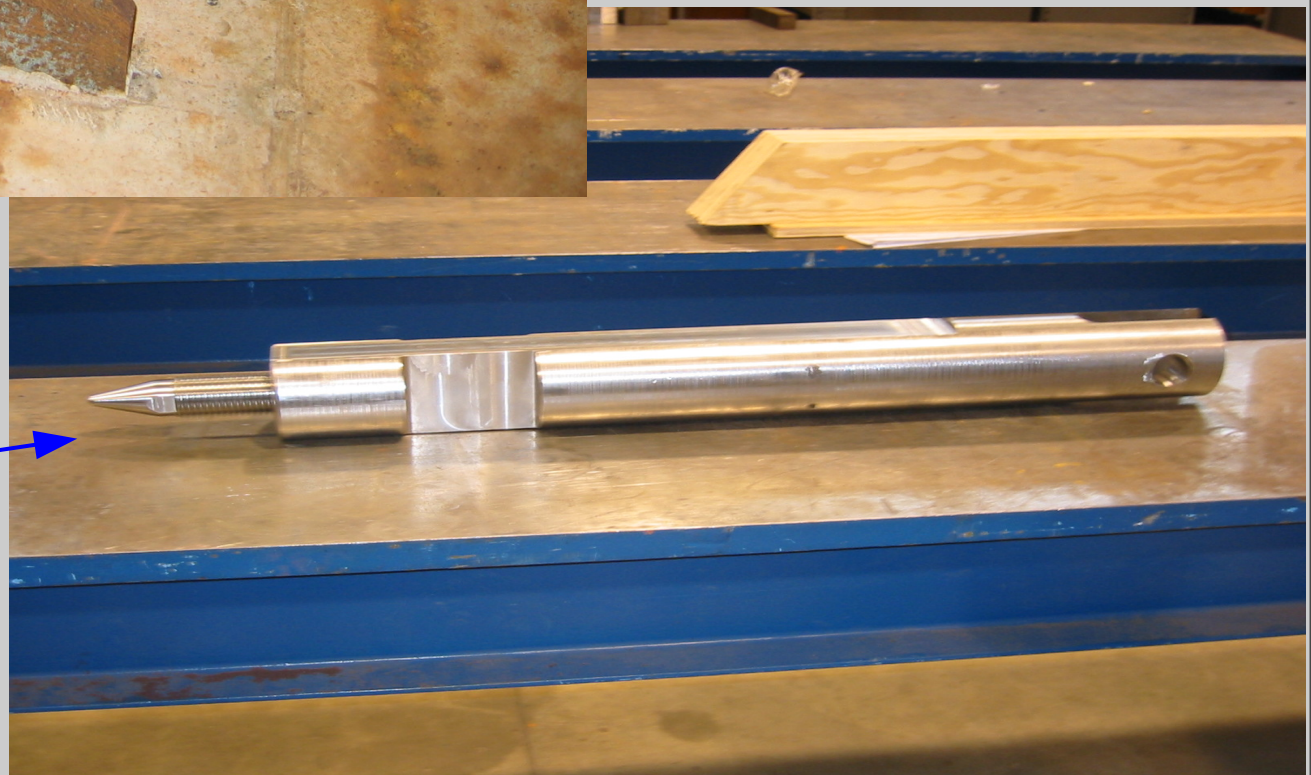
Clean, inspected, tested, and prepared lifting lugs. All okay, ready for lifting!

New Stainless steel rods to hang absorber plates (16 in hand).

- Continued offline due to 25m absorber problem.
- Two 25 ton steel blocks dropped into the beamline. Repair plans/work in progress:
  - 16 of 22 stainless steel lifting rods have arrived. Rest to be delivered Wednesday.
  - First absorber plated successfully raised today, second one on the way up!
  - Continue to raise absorber plates, should be done this week.
